Water Compliance Inspection Report

**NPDES
Inspection Report**

Maarhuis Dairy, LLC

Sumas, Washington

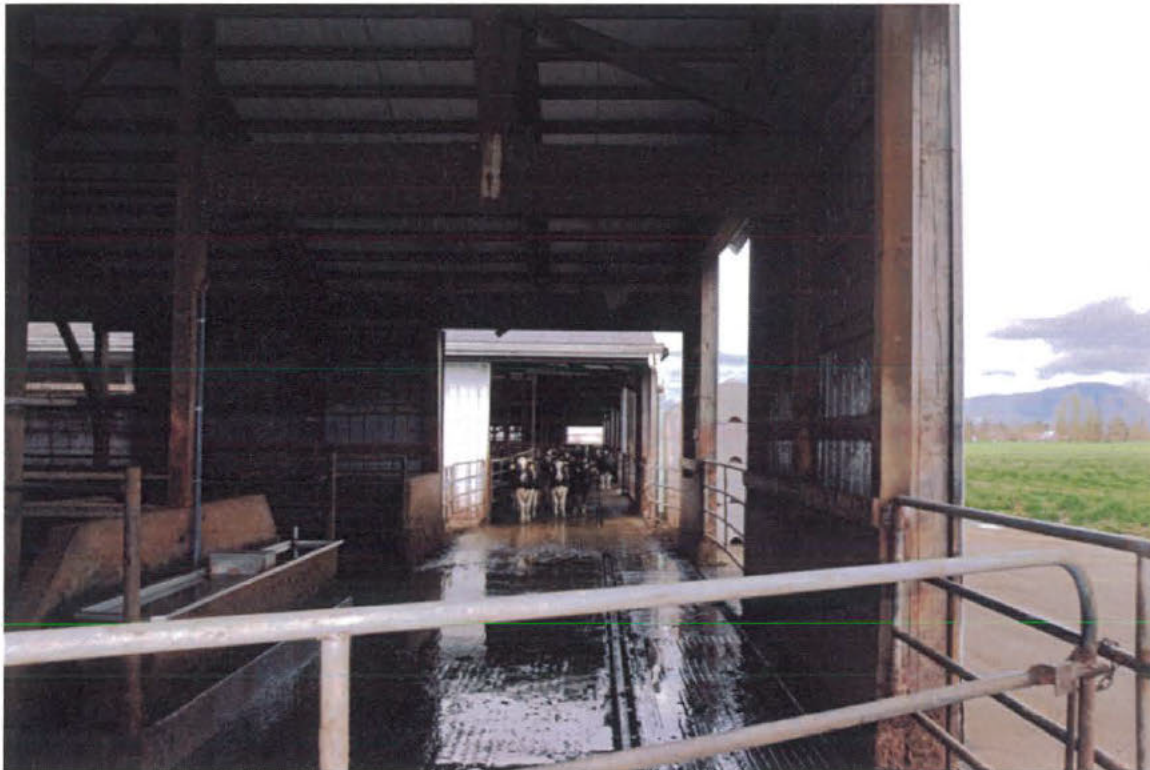
Photo 1. Shows the self cleaning alleys between barns.

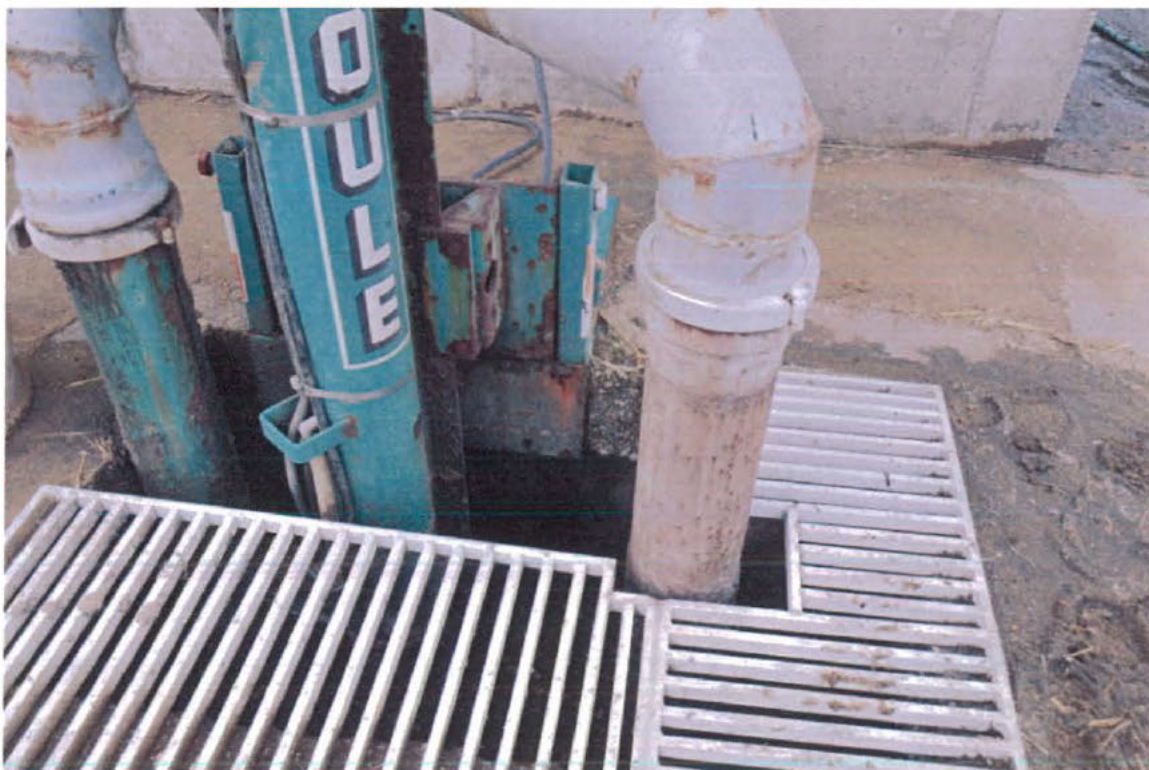
Photo 2. Pump lift station from underground collection tank.

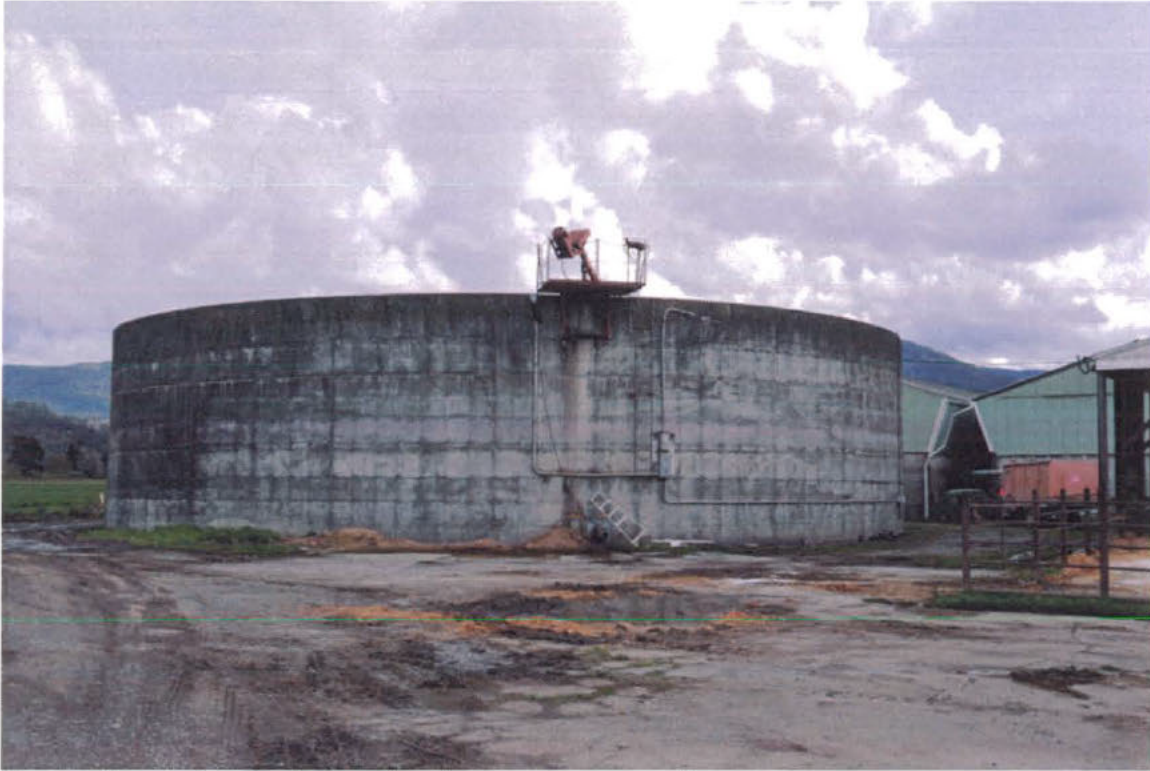
Photo 3. Large above ground waste storage tank.

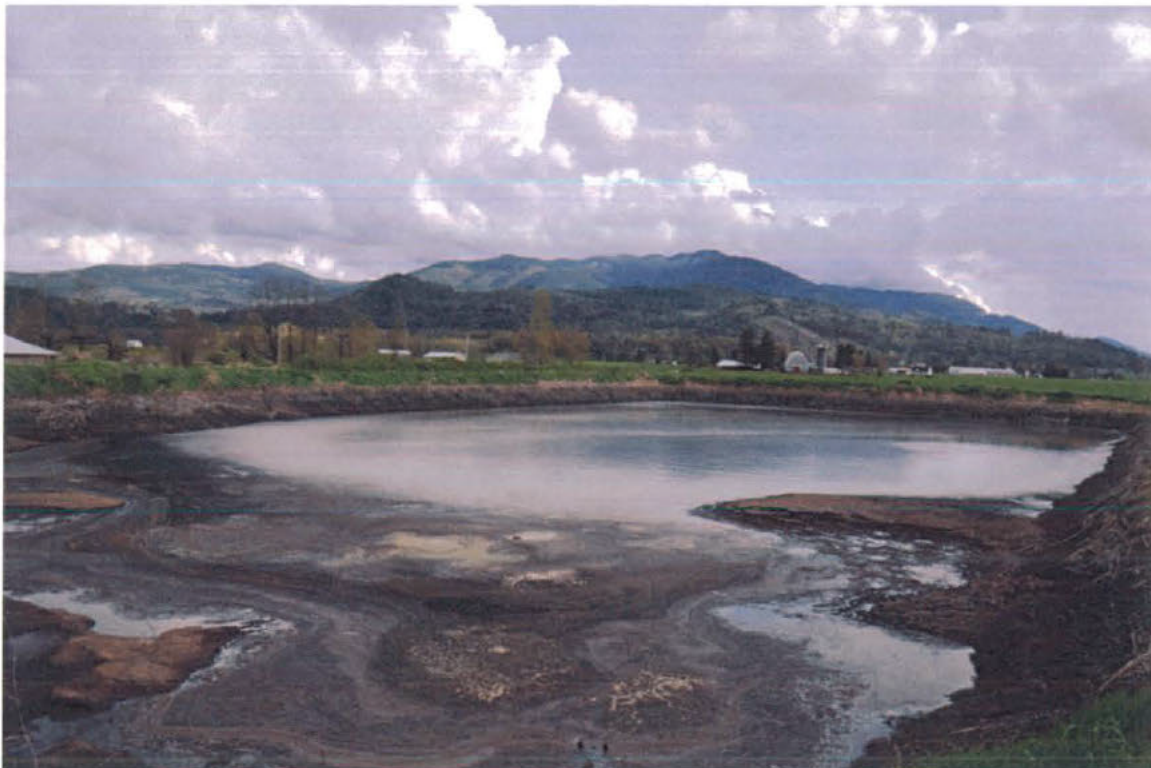
Photo 4. One of several waste water storage lagoons on the facility.

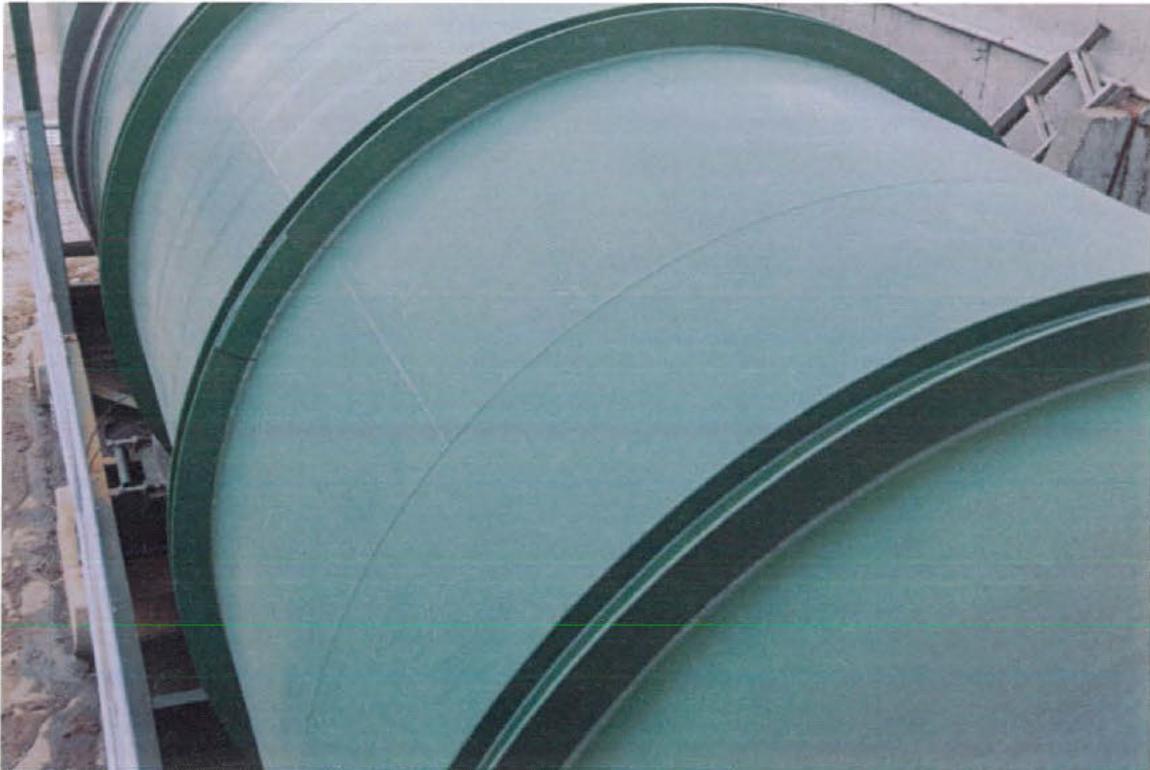
Photo 5. Maarhuis Dairy installed this solid drying system to help reduce the waste system solids.

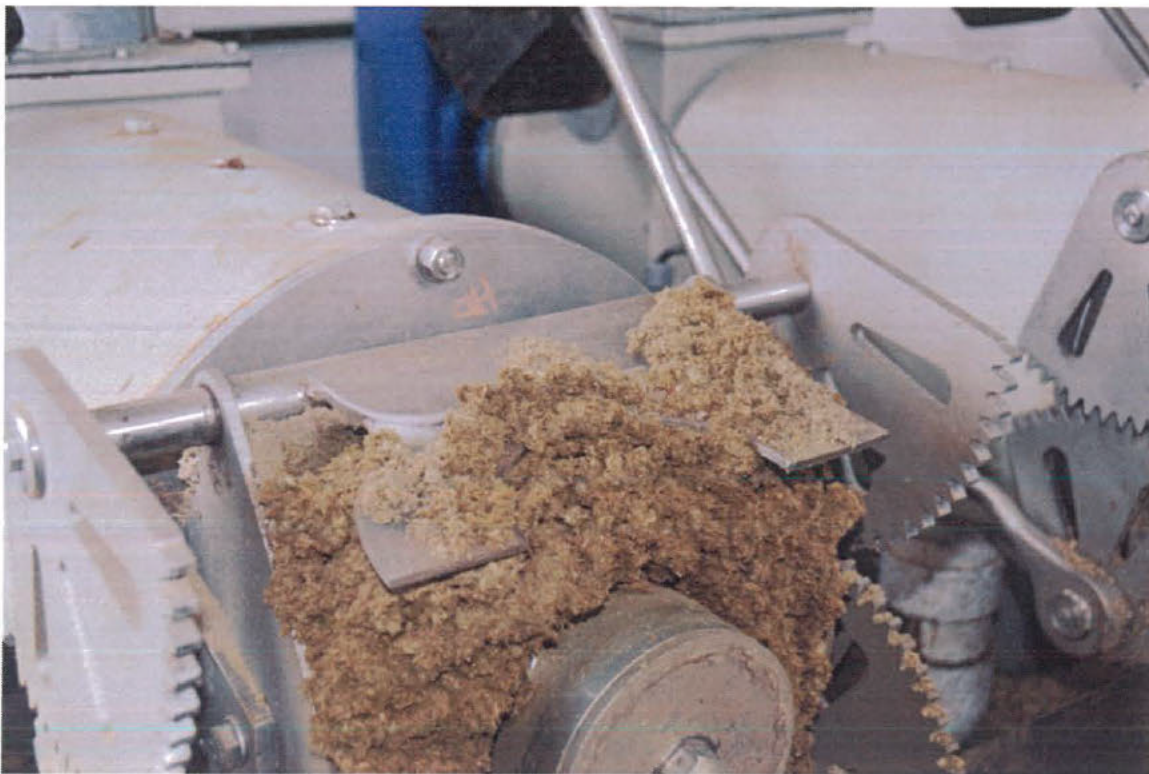
Photo 6. Dry solids coming out of the dryers.

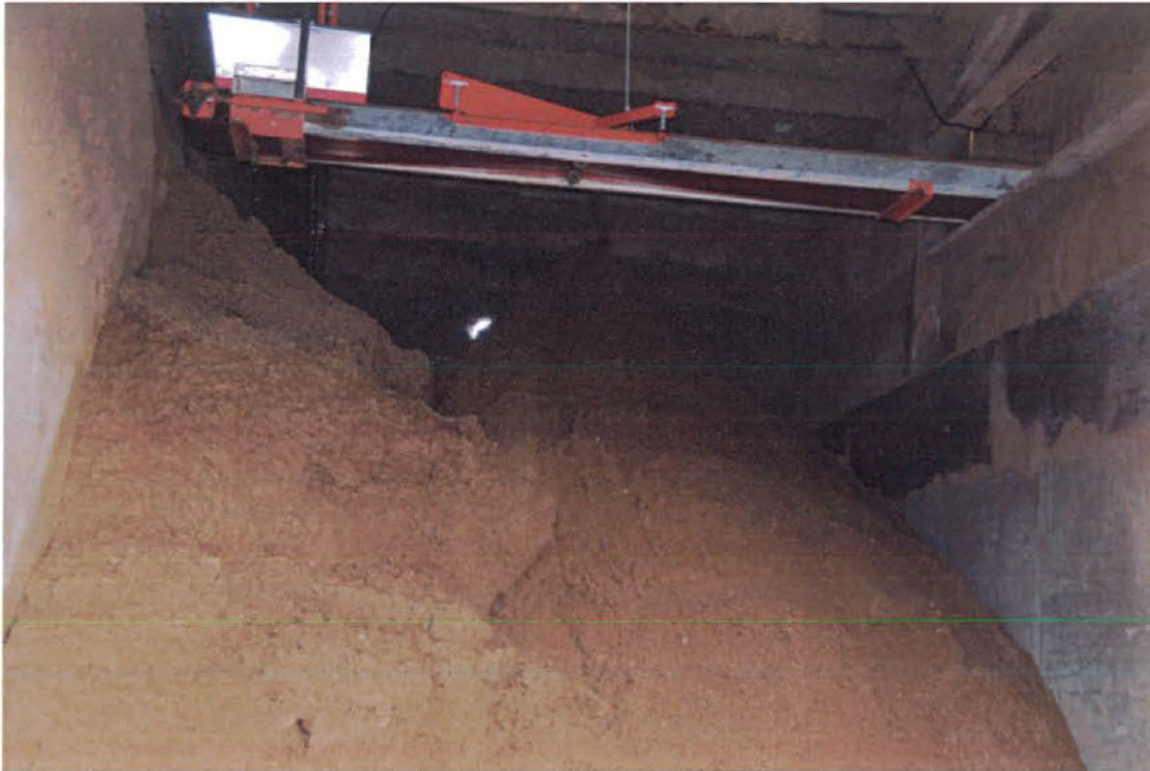
Photo 7. Dried solids stored in covered building. Facility uses it as a composting material and bedding for the cows.
